DATAFILE BULLETIN

FILE UNDER: Receivers
 ER-42-A, B & C
 BULLETIN NO 1086-4
 DATE: November 1967

Equipment: 406—470 MHz MASTR Professional Receivers

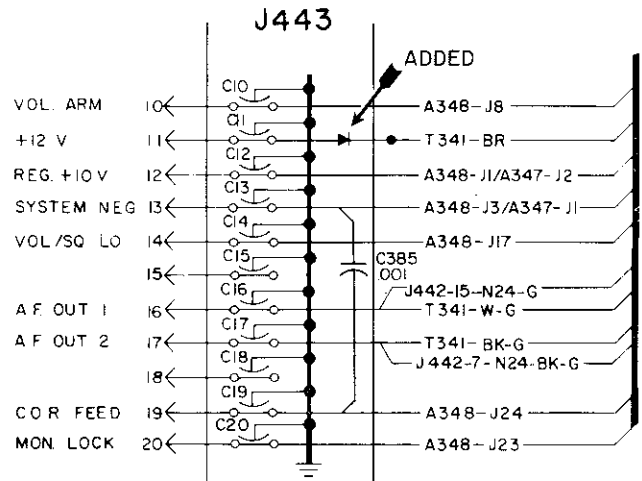
Figure 1 - Showing Diode Added

Symptom: **AUDIO OUTPUT TRANSISTOR FAILS**

Cause: Negative voltage spikes, induced in the supply lead by external transients.

This revision added a diode in series with the +12 VDC supply lead to prevent negative spikes from reaching the output transistor. See Figure 1.

Field Solution: The diode should be added to receivers which do not have it, as shown in Figure 1. Connect the anode lead to J443-11 and the cathode lead to the brown wire from the audio output transformer. Use sleeving where necessary.

Ordering Info:	Symbol Number	GE Part No.	Description
	CR401	4037822-P1	Diode, silicon: PIV 400, sim to SC4.
