DATAFILE BULLETIN

FILE UNDER: Receivers
 ER-41-C

BULLETIN NO: 1094-1

Equipment: 132—174 MHz MASTR Progress Line 5-watt receivers

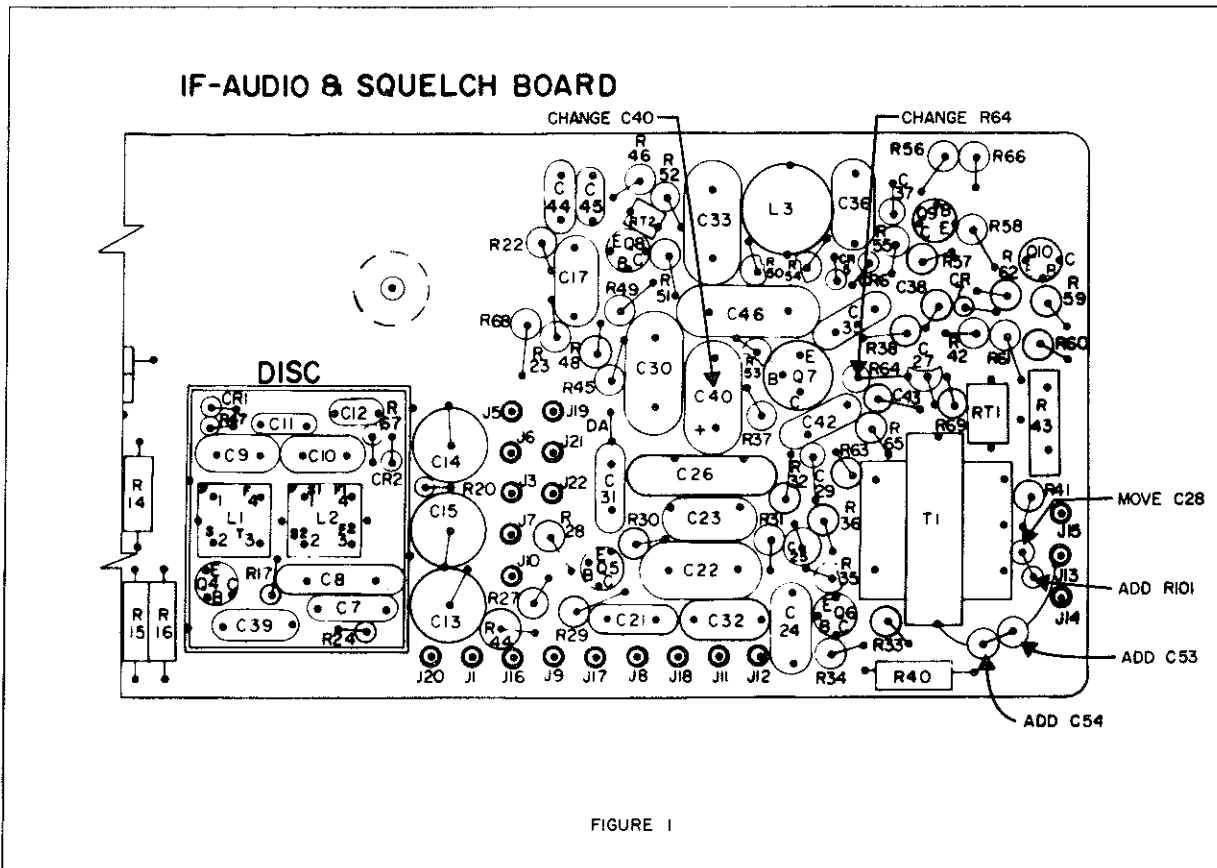
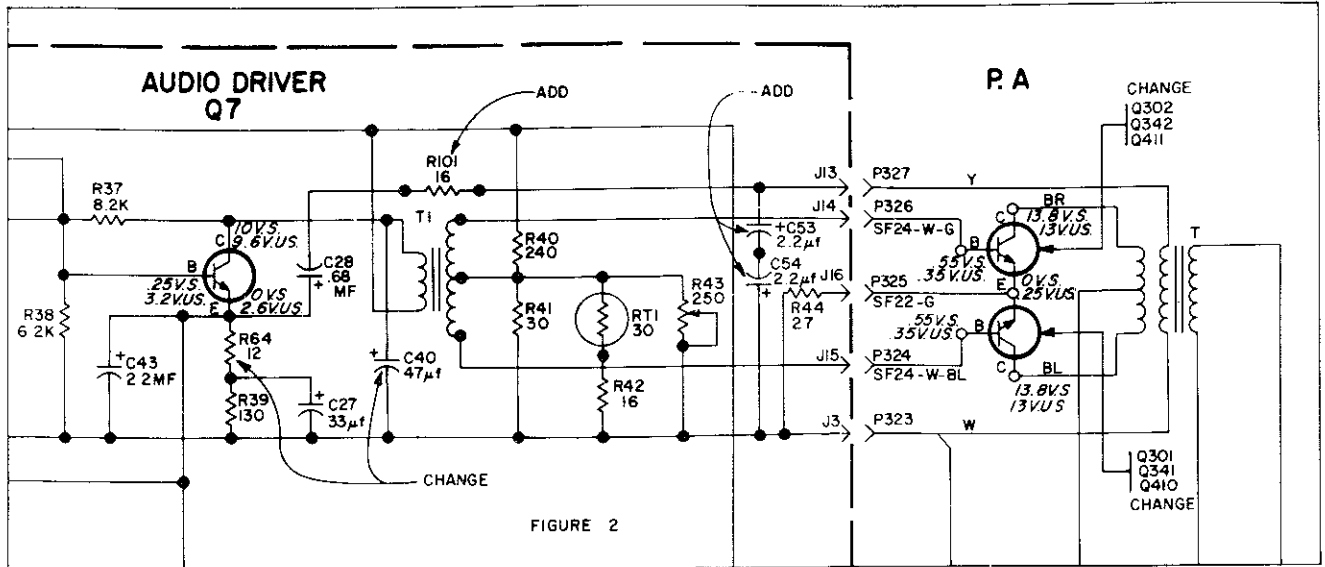
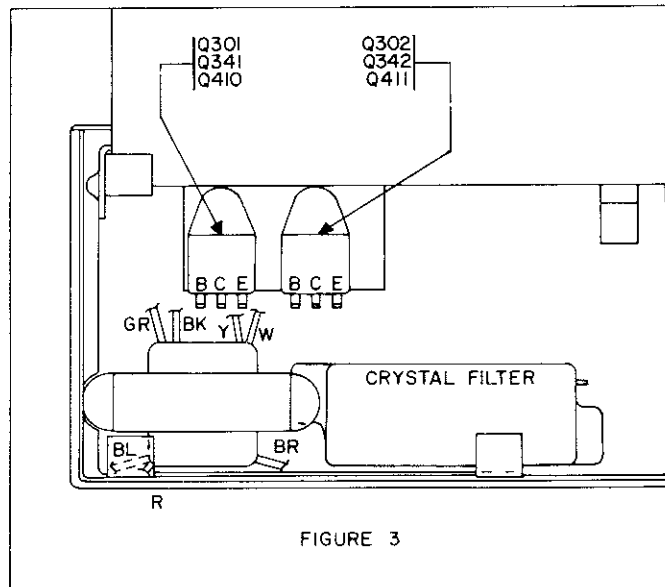
Purpose: **TO OFFER A FIELD MODIFICATION TO REPLACE THE AUDIO OUTPUT
 TRANSISTORS FROM 19A115948-P1 (no longer available) to
 19A116203-P2**

The lead connections are different from the 19A115948-P1 transistor.

Field Change: The 19A116203-P2 transistor can be used in place of the
 19A115948-P1 but the following changes have to be made:
 (Refer to Figure 1, 2, & 3)

1. Change R64 from 18 ohms to 12 ohms.
2. Change C40 from 0.22 μ F to 0.47 μ F.
3. Add C53 and C54 (2.2 μ F) in series. Solder the can (Neg.) sides together. Connect the positive side of C53 to J13 pad and the positive side of C54 to system negative near T1.
4. Unsolder and carefully remove C28 (0.68 μ F). Solder the positive (+) side of C28 in the pad that connects to C43 & R64.
5. Solder one side of R101 (16 ohms) to the pad connecting J13. Solder the other side of R101 to the negative (-) side of C28.
6. Replace the two audio output transistors with 19A116203-P2. (see Fig. 3) Mount each transistor with a 19A116023-P2 insulator plate and a 19A116022-P1 bushing. Use silicon grease on both sides of the insulator plate.

7. TEST PROCEDURE CHANGE: Turn the squelch control fully counterclockwise. Connect a milliammeter in series with the +12 volt lead at P443-11. With no signal in, adjust the PA bias adjust (R43) for a reading of approximately 20 milliamps.
