DATAFILE BULLETIN

BULLETIN NO: 1085-1

DATE: March 1965

Equipment: 132—174 MC MASTR Progress Line Receivers

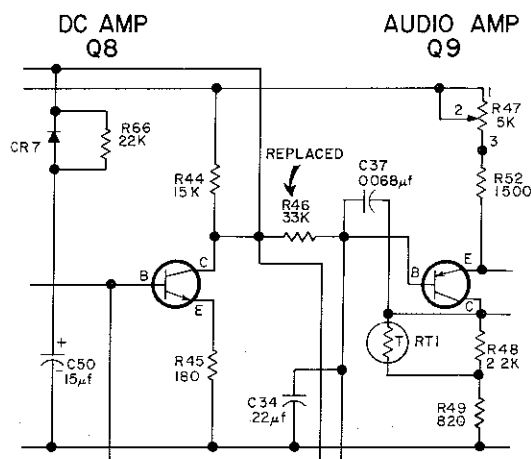
Fig. 1 - Old Circuit

This revision provided decoupling between the output of the DC amplifier and the input of the first audio stage to reduce rumble at low volume settings. Resistor R46 was replaced by decoupling network R74-R75-C71 on the IF/Audio & Squelch Board.

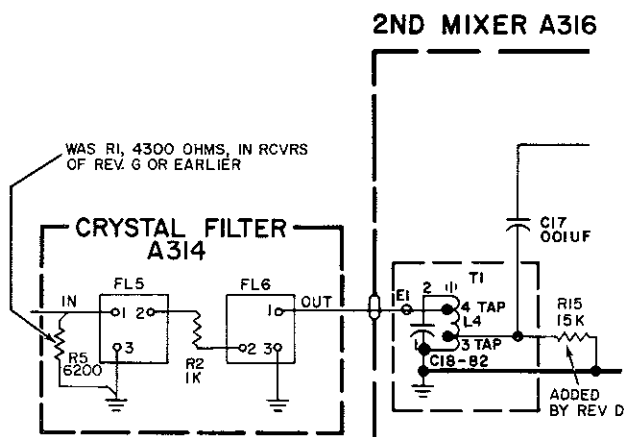
Fig. 1 - 2-Section Crystal Filter

This revision replaced Hi-IF crystal filters FL5 and FL6 (GE Part No. 19B304094-G4) with single-unit filter 19B206692-G1 to improve selectivity and simplify manufacturing. The old and new filters are shown in Figures 1 and 2. Note that the filter-loading resistors were also changed, and R15 was deleted on 2nd Mixer Board A316.

This revision will not normally be made in the field unless filter FL5 or FL6 fails. It will then be necessary to replace both filters with the new single-unit filter:

1. Remove FL5 and FL6 with their loading resistors. Mounting screws for the filters are accessible by removing the Multiplier Selectivity.

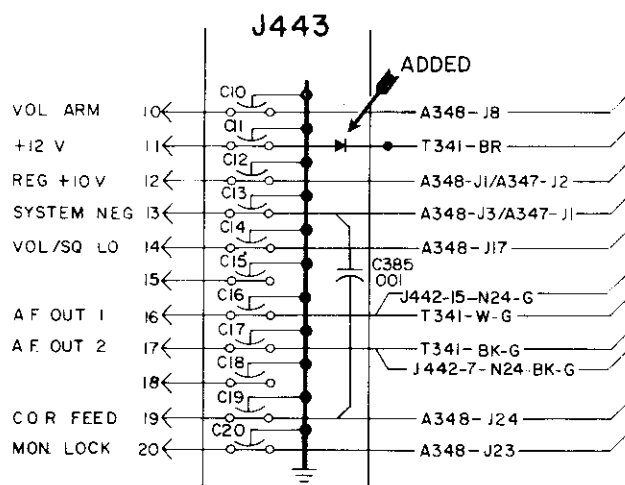
Fig. 1 - Showing Diode Added

Symptom: AUDIO OUTPUT TRANSISTOR FAILS

Cause: Negative voltage spikes, induced in the supply lead by external transients.

This revision added a diode in series with the +12 VDC supply lead to prevent negative spikes from reaching the output transistor. See Figure 1.

Field Solution: The diode should be added to receivers which do not have it, as shown in Figure 1. Connect the anode lead to J443-11 and the cathode lead to the brown wire from the audio output transformer. Use sleeving where necessary.

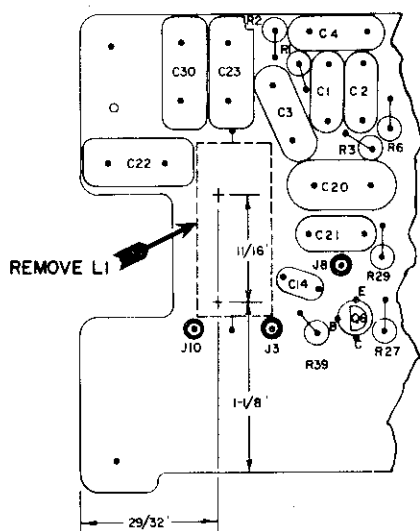
Fig. 1 - Before Modif.

Symptom: 60-CYCLE HUM ON AUDIO OUTPUT (ESPECIALLY IN STATIONS EQUIPPED WITH COMPRESSORS)

Cause: Magnetic coupling between power transformer T501 on Station Power Supply EP-38-A and choke L1 on Channel Guard Board 19C303550-G1 (Rev. E or later), 19C303550-G2 (Rev. D or later), or 19C303550-G3.

1. Remove and discard the tubular choke L1 (19A115690-P2).
2. Drill two 1/8" holes in the Channel Guard board at the locations shown in Figure 1.
