DATAFILE BULLETIN

FILE UNDER: Receivers
ER-42-B
BULLETIN NO: 1086-1
DATE: March 1965

Equipment: 406—470 MC MASTR Progress Line Receivers

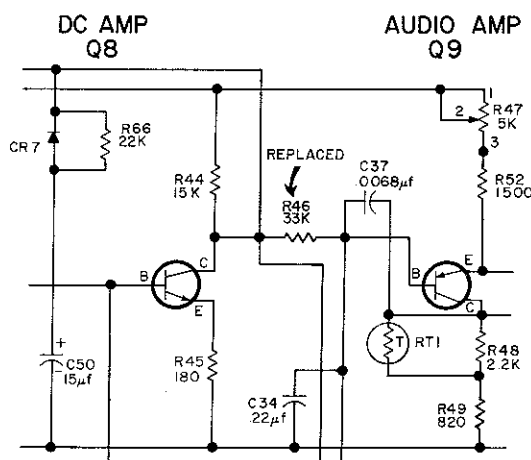
Fig. 1 - Old Circuit

Symptom: RUMBLE AT LOW VOLUME SETTING

This condition is noticed as a low rumble when the VOLUME control is set at a low level and the SQUELCH control is set at critical.

Cause: Excessively sharp voltage variations on DC amplifier output which were coupled into audio amplifier.

This revision provided decoupling between the output of the DC amplifier and the input of the first audio stage to reduce rumble at low volume settings. Resistor R46 was replaced by decoupling network R74-R75-C71 on the IF/Audio & Squelch Board.

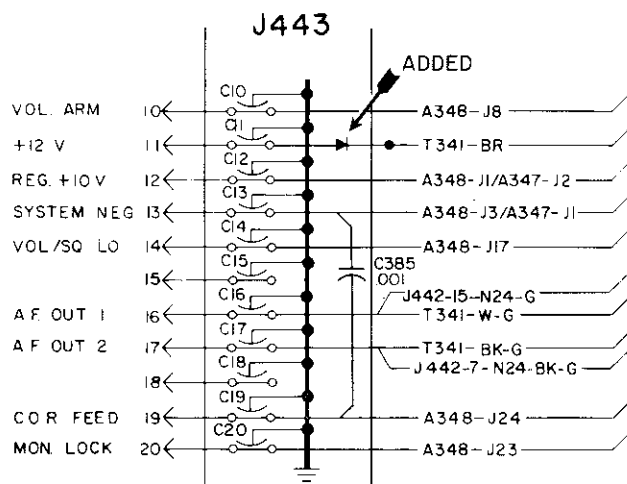
Figure 1 - Showing Diode Added

Symptom: AUDIO OUTPUT TRANSISTOR FAILS

Cause: Negative voltage spikes, induced in the supply lead by external transients.

This revision added a diode in series with the +12 VDC supply lead to prevent negative spikes from reaching the output transistor. See Figure 1.

Field Solution: The diode should be added to receivers which do not have it, as shown in Figure 1. Connect the anode lead to J443-11 and the cathode lead to the brown wire from the audio output transformer. Use sleeving where necessary.

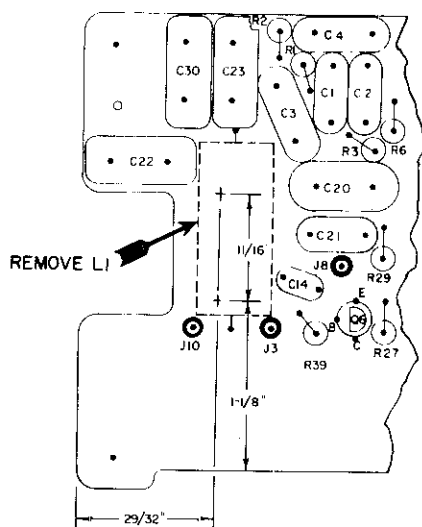
Fig. 1 - Before Modif.

Symptom: 60-CYCLE HUM ON AUDIO OUTPUT (ESPECIALLY IN STATIONS EQUIPPED WITH COMPRESSORS)

Cause: Magnetic coupling between power transformer T501 on Station Power Supply EP-38-A and choke L1 on Channel Guard Board 19C303550-G1 (Rev. E or later), 19C303550-G2 (Rev. D or later), or 19C303550-G3.

1. Remove and discard the tubular choke L1 (19A115690-P2).
2. Drill two 1/8" holes in the Channel Guard board at the locations shown in Figure 1.

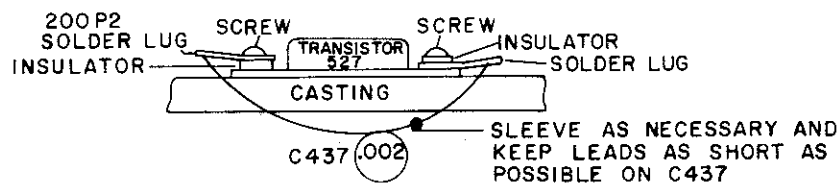
FIG 1

INSTABILITY OF AUDIO POWER AMPLIFIER USING TRANSISTOR
F115527.

Parameter variations in transistors from different vendors.

This revision added capacitor (C437) from collector of audio PA transistor (Q410) to ground and eliminated the instability.

1. Solder C437 in circuit as shown in Fig. 1.
2. Stamp or mark unit with "Rev. C".
