# DATAFILE BULLETIN

FILE UNDER: Receivers  
ER-41-C

BULLETIN NO: 1094-1

Equipment: 132—174 MHz MASTR Progress Line 5-watt receivers

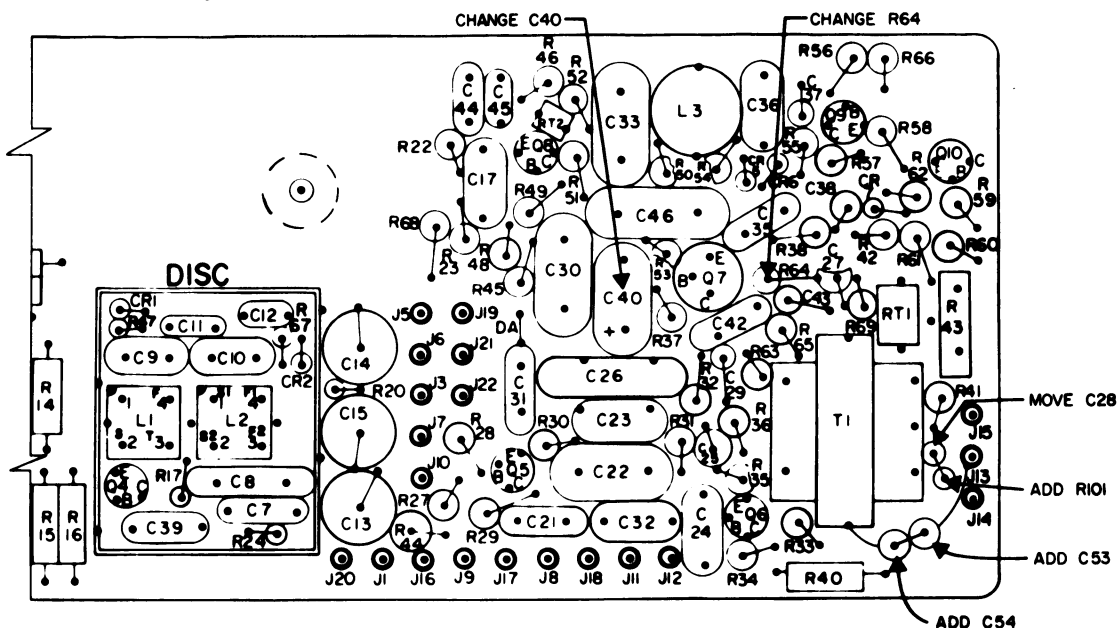
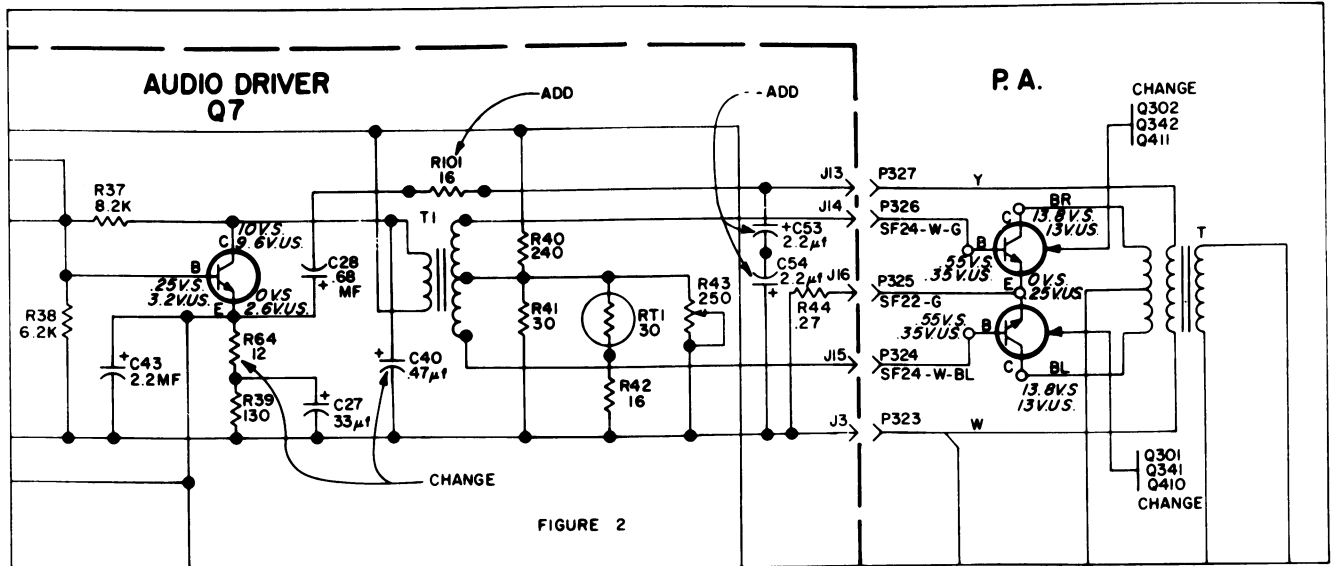
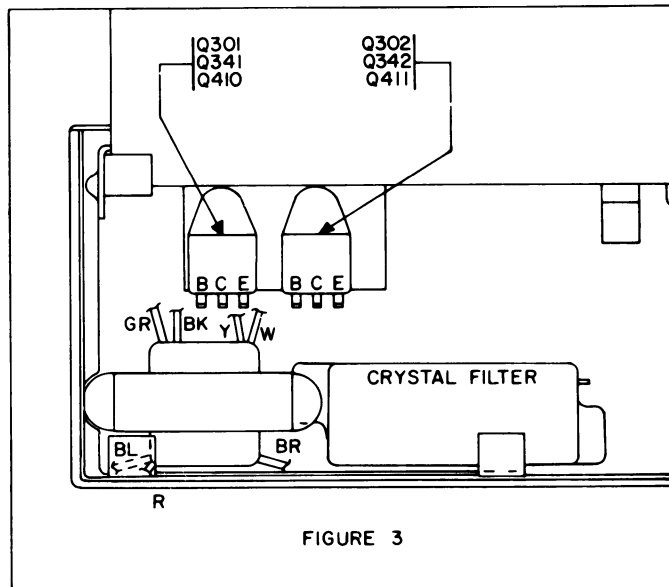
FIGURE 1

TO OFFER A FIELD MODIFICATION TO REPLACE THE AUDIO OUTPUT TRANSISTORS FROM 19A115948-P1 (no longer available) to 19A116203-P2

The 19A116203-P2 transistor can be used in place of the 19A115948-P1 but the following changes have to be made: (Refer to Figure 1, 2, & 3)

The lead connections are different from the 19A115948-P1 transistor.

1. Change R64 from 18 ohms to 12 ohms.
2. Change C40 from 0.22  $\mu$ F to 0.47  $\mu$ F.
3. Add C53 and C54 (2.2  $\mu$ F) in series. Solder the can (Neg.) sides together. Connect the positive side of C53 to J13 pad and the positive side of C54 to system negative near T1.
4. Unsolder and carefully remove C28 (0.68  $\mu$ F). Solder the positive (+) side of C28 in the pad that connects to C43 & R64.
5. Solder one side of R101 (16 ohms) to the pad connecting J13. Solder the other side of R101 to the negative (-) side of C28.
6. Replace the two audio output transistors with 19A116203-P2. (see Fig. 3) Mount each transistor with a 19A116023-P2 insulator plate and a 19A116022-P1 bushing. Use silicon grease on both sides of the insulator plate.

7. TEST PROCEDURE CHANGE: Turn the squelch control fully counterclockwise. Connect a milliammeter in series with the +12 volt lead at P443-11. With no signal in, adjust the PA bias adjust (R43) for a reading of approximately 20 milliamps.
