DATAFILE BULLETIN

FILE UNDER: Receivers
ER-42-B
BULLETIN NO: 1086-1
DATE: March 1965

Equipment: 406—470 MC MASTR Progress Line Receivers

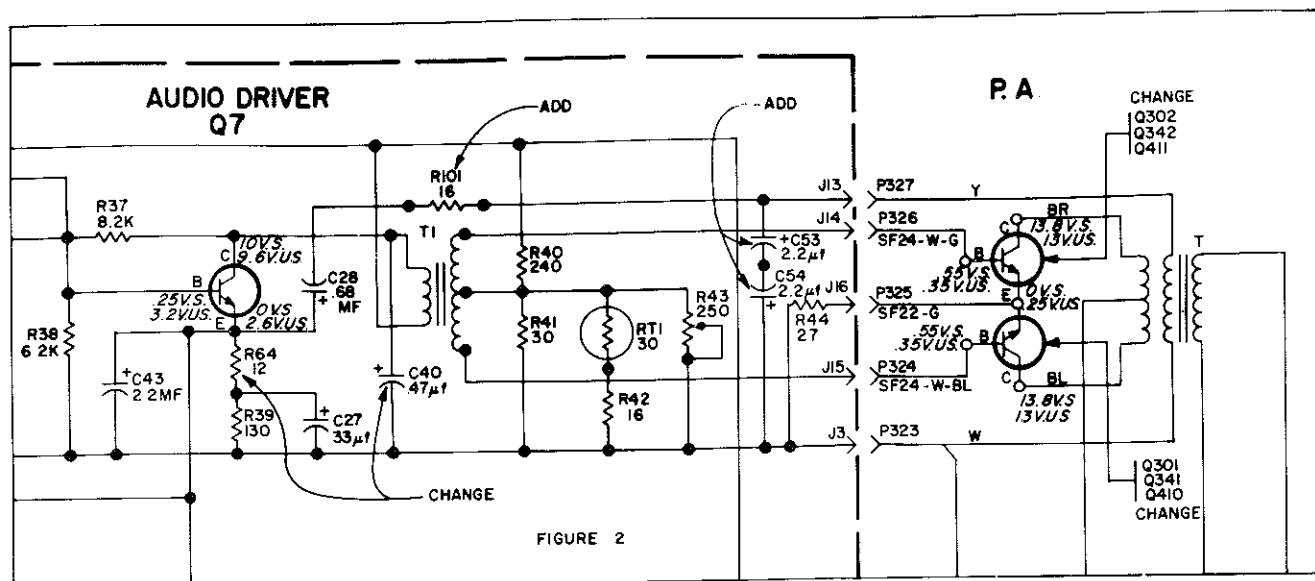
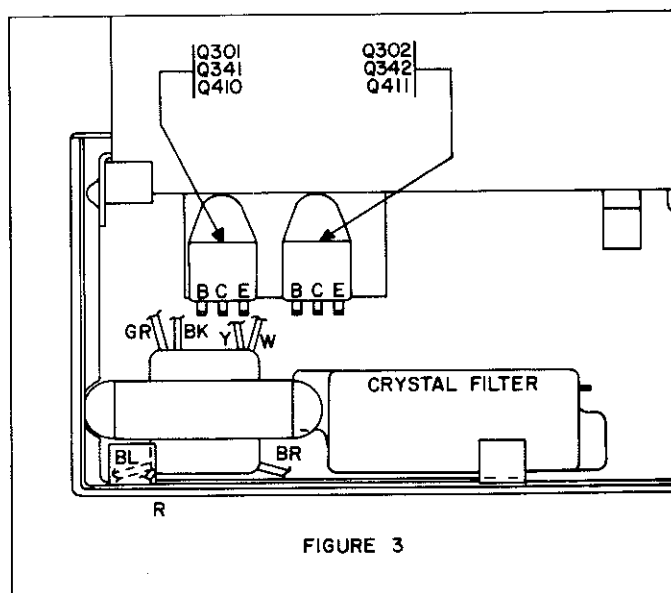
FIGURE 1

TO OFFER A FIELD MODIFICATION TO REPLACE THE AUDIO OUTPUT TRANSISTORS FROM 19A115948-P1 (no longer available) to 19A116203-P2

The 19A116203-P2 transistor can be used in place of the 19A115948-P1 but the following changes have to be made: (Refer to Figure 1, 2, & 3)

1. Change R64 from 18 ohms to 12 ohms.
2. Change C40 from 0.22 μ F to 0.47 μ F.
3. Add C53 and C54 (2.2 μ F) in series. Solder the can (Neg.) sides together. Connect the positive side of C53 to J13 pad and the positive side of C54 to system negative near T1.
4. Unsolder and carefully remove C28 (0.68 μ F). Solder the positive (+) side of C28 in the pad that connects to C43 & R64.
5. Solder one side of R101 (16 ohms) to the pad connecting J13. Solder the other side of R101 to the negative (-) side of C28.
6. Replace the two audio output transistors with 19A116203-P2. (see Fig. 3) Mount each transistor with a 19A116023-P2 insulator plate and a 19A116022-P1 bushing. Use silicon grease on both sides of the insulator plate.
