A Modification for the Helper Sinadder Linear 5 (also known as the SL-105)

Supplied by Paul N2XZF

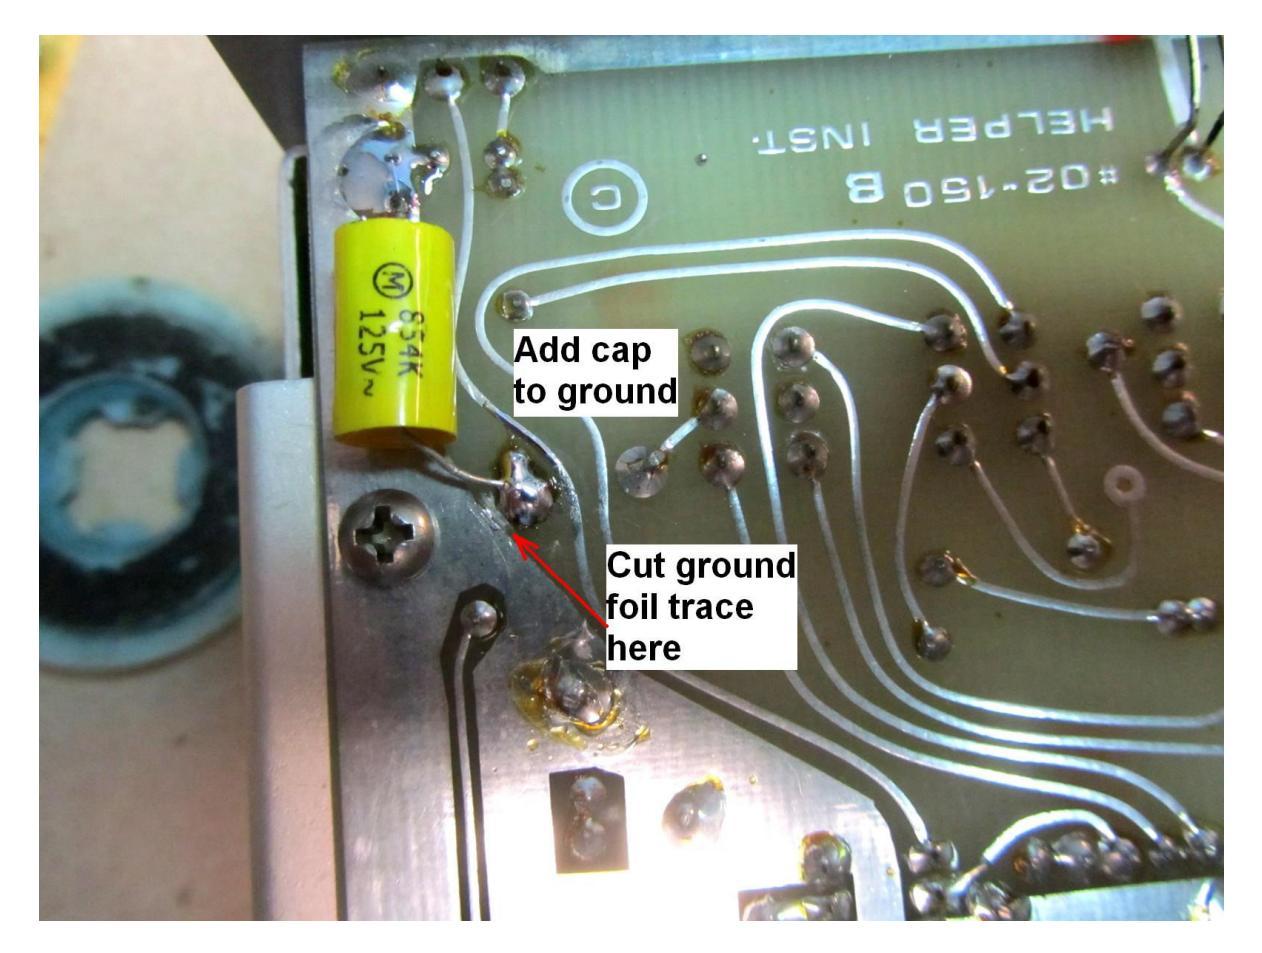
In the photo you can see the area where I cut the trace and soldered in the capacitor. I actually used a \sim 0.8 uF cap because that's what I had on hand.

The fix is relativity simple: lift the test input "ground" and connect it to ground through a 1 uF capacitor. On the SL-105, the test lead "ground" and shield are connected on the circuit board to the rest of the ground plane by a pad that is joined by a rather small trace, making the modification easy. Simply cut the trace, and connect the isolated pad to the chassis ground through a 1 uF capacitor.
