# MAINTENANCE MANUAL 800 MHz POWER AMPLIFIER BOARD 19C851822G1

Power Amplifier Board 19C851822G1 is used in the MDX, MTD, MVS, and TMX-8825 800 MHz mobile radios. This board is located under the top cover of the radio.

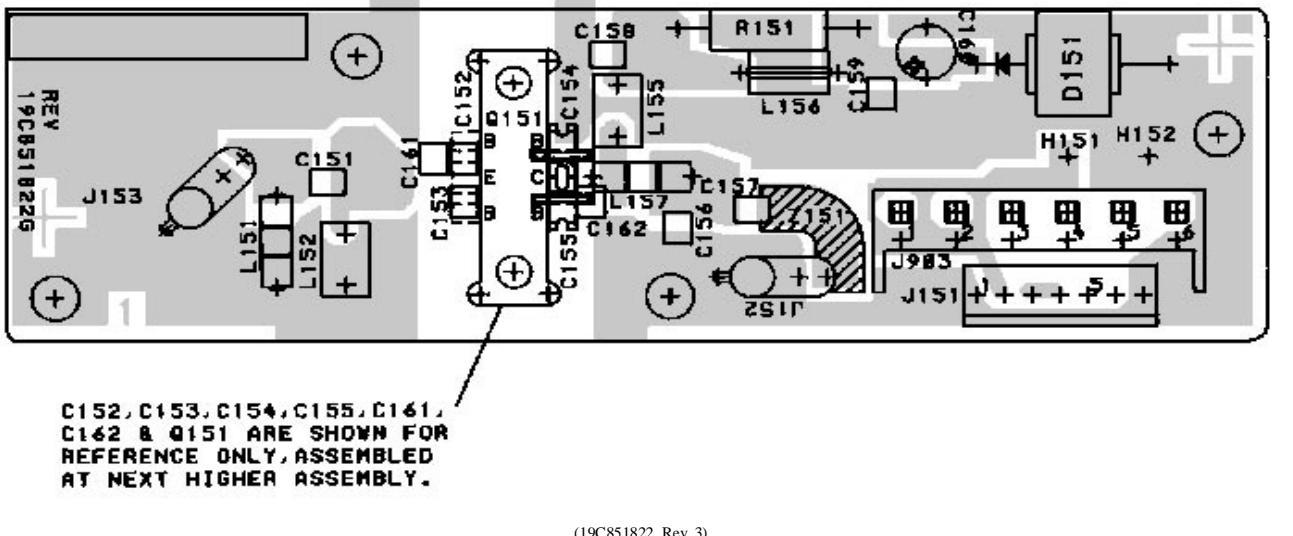
(19C851822, Rev. 3) (19C851821, Rev. 2)

COMPONENT SIDE

There are nine chip mica capacitors on the PA Board. Four of these chips (C152, C153, C161, and C162) are on the transistor leads (Q151). If any are removed, replace them with a new part since they are easily damaged. Place them in the exact positions shown in the outline diagram. Failure to do this reduces amplifier gain, bandwidth, and efficiency. C154 and C155 are vertically mounted, uncased mica capacitors. They must mount against Q151.

- Re-install C154 and C155. Install the new replacement capacitors C152, C153, C161, and C162 in the exact positions shown on the outline diagram. Solder carefully to prevent damaging them. NOTE: Capacitors C161 and C162 mount against C152 and C155 respectively.

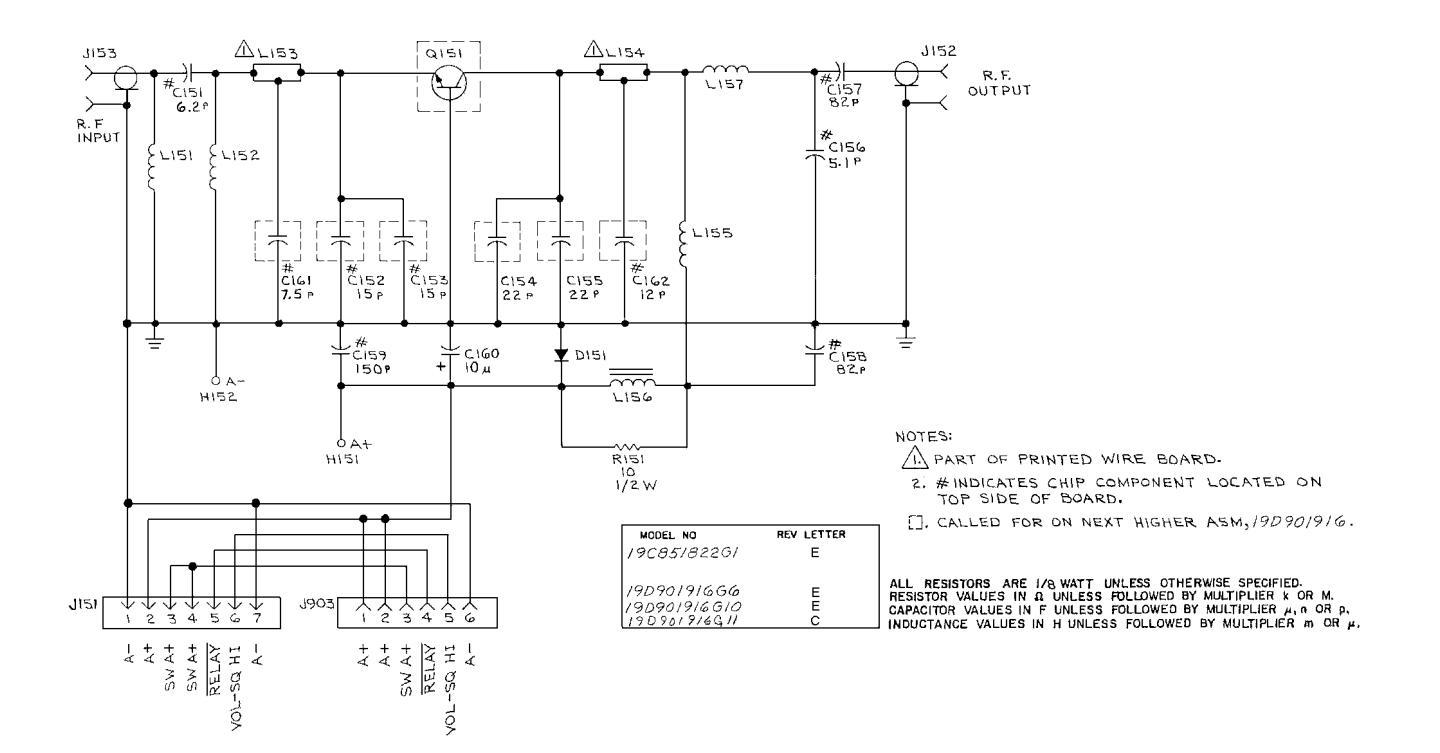
(19C851818, Sh. 1, Rev. 5)

## POWER AMPLIFIER BOARD

The PA Board consists of a single stage RF power amplifier in a common base configuration. Also included on the board is a diode for reverse power protection. Two small jacks are used to connect approximately ten watts of drive to the PA Board and to take the thirty watt output from the final amplifier. A+ power is supplied to six pin connector J903 through feedthru capacitor assembly A903. Diode D151 provides reverse polarity protection. If the A+ power polarity is accidentally reversed, D151 conducts, causing the A+ fuse is the power cable to blow, removing power from the radio and preventing serious damage.

A+ is supplied to the collector of power transistor Q151 through a network consisting of inductors L155 and L156, resistor R151 and capacitors C158, C159, and C160. In addition to enhancing stability, these components also prevent RF from getting onto the A+ line.

The driver output from the RF Board (10 watts and 50 ohms impedance) is matched to the emitter of Q151 by capacitors C151, C152, C153, and C161 and inductors L151 and L153. Inductor L152 provides a DC return for class "C" operations.

Once the drive is amplified to approximately thirty watts by Q151, the transistor is matched back up to 50 ohms by capacitors C154, C155, C156, and C162, and inductors L154 and L157. Capacitor C157 is a DC blocking capacitor to prevent DC voltage from appearing on the amplifier output. The amplified signal is coupled through a coaxial cable to the RF Board that contains the transmitter filter, antenna switch, and power leveling circuitry.
