MAINTENANCE MANUAL

CUSTOM MVP REPEATER SYSTEM

LBI32772 A

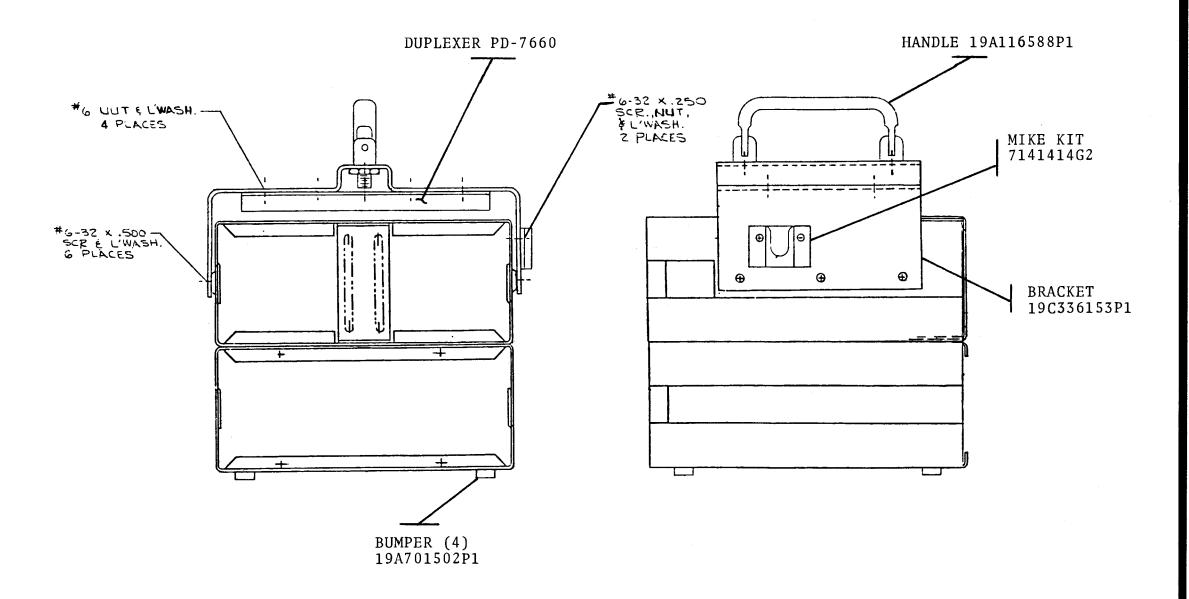
(TE1543, Rev. 0)

OUTLINE DIAGRAM

CUSTOM MVP REPEATER SYSTEM HOUSING 19C336152G1

The Housing for the Custom MVP repeater unit is shown on Outline Diagram TE1543. The Custom MVP radio unit was inserted into the top cavity and the AC power supply was installed into the lower cavity of the Housing.
