# MAINTENANCE MANUAL

## FRONT COVER ASSEMBLY

### 19D903620G1

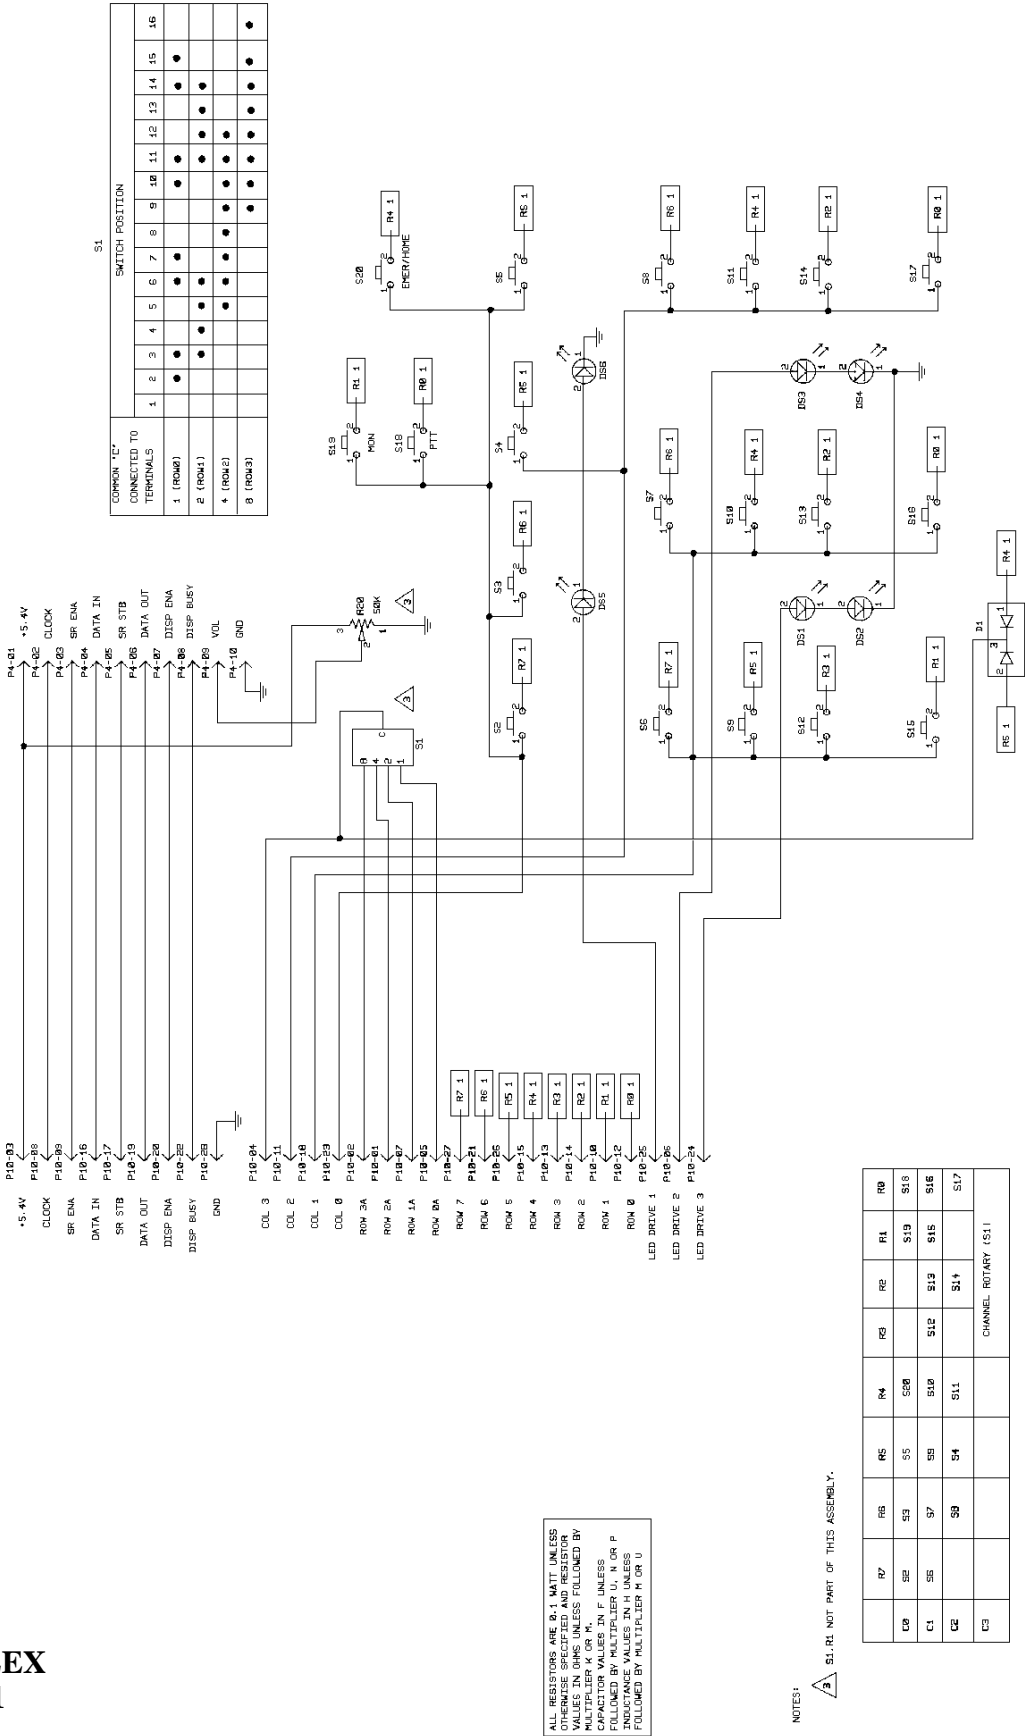
KEYPAD FLEX  
19D902810P1

(19D902810, Sh. 4, Rev. 5)

The keypad is arranged in a four (4) column by eight (8) row matrix. It is read by successively setting each column output to a logic 0 and examining the row inputs. Any row at logic 0 when examined indicates a closed switch. Three (3) columns are used to read the keypad switches and the fourth column reads group/channel switch S1. Specifically, columns 0 (COL 0) through 2 (COL 2) are utilized to read the switches on the flex and column 3 (COL 3) is used to read S1. See the charts on the Keypad Flex schematic for details on column-to-row connections and the coding of S1.

Volume control (R20) and group/channel switch (S1) are soldered to this flex. The I/O Microcontroller on the Control Board uses the logic on the LCD Board to read the switches. On M-PA Scan and System model radios the four (4) switches on the top of the keypad (S2, S3, S4 and S5) are used. Keypad switches S6 through S17 are utilized in M-PA System model radios. Switches S18, S19 and S20 are the PTT, Monitor and Emergency/Home switches respectively.
